ERDC/CERL TR-01-11

## **Structural Evaluation of Aircraft Hangar 46, Corpus Christi Army Depot**

Ghassan K. Al-Chaar, Daniel J. Randolph,  
Gregory E. Lamb, and Pramod J. Desai

February 2001

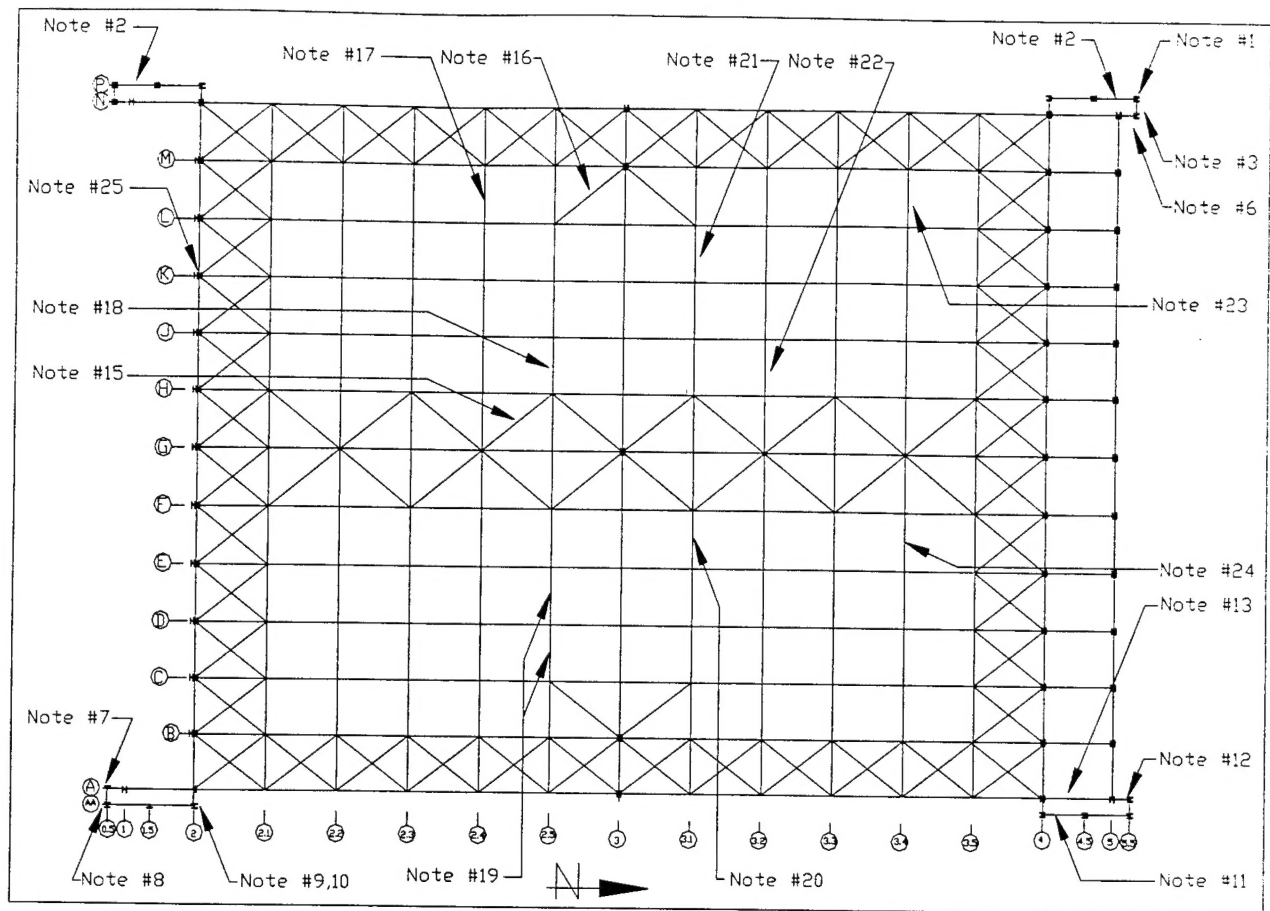
Figure 2-3. Locations of deficient structural members.

The following notes on specific deficiencies were recorded from observations made during the inspection. These notes are related to strength reduction and in many cases indicate the need for repairs. For location of members on a plan view of the hangar, see Figure 2-3. Notes in parentheses indicate member size.

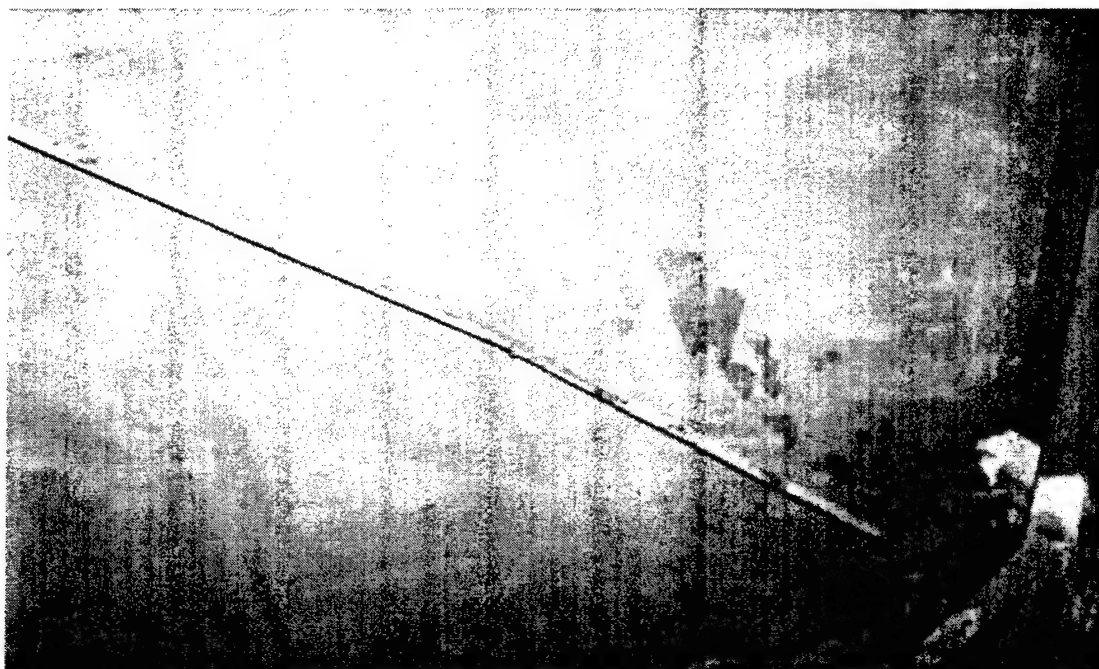
1. Tie rod (7/8 in. diameter) located at column P5.5, is bent. See Appendix A, Figure A-1.
2. Tie rods (7/8 in. diameter) located at columns P0.5, P1.5, P4.5, and P5.5 are loose.
3. Horizontal brace (10-I-21) located at second floor, between columns P5.5 and N5.5, is buckling. See Figure A-2.
4. Hangar door wheels are rusting and deteriorating. See Figure A-3.
5. Vertical members by handles on hangar doors are dented, likely resulting from opening doors with hooks and chains.
6. Concrete is spalling at column N5.5 (8-H-31). See Figure A-4.
7. Spalled concrete allowed major corrosion of column A0.5 (8-H-31), resulting in an estimated strength reduction of up to 30 percent. See Figure A-5.
8. Minor corrosion was found at the base of column AA0.5 (12-I-25).

Figure A-1. Buckled tie rod (7/8 in. diameter) near Column P5.5.

1. Replace the bent tie rod (7/8 in. diameter) attached to column P5.5 with identical or larger member that has the same connection details with same configuration of bolts and welds.

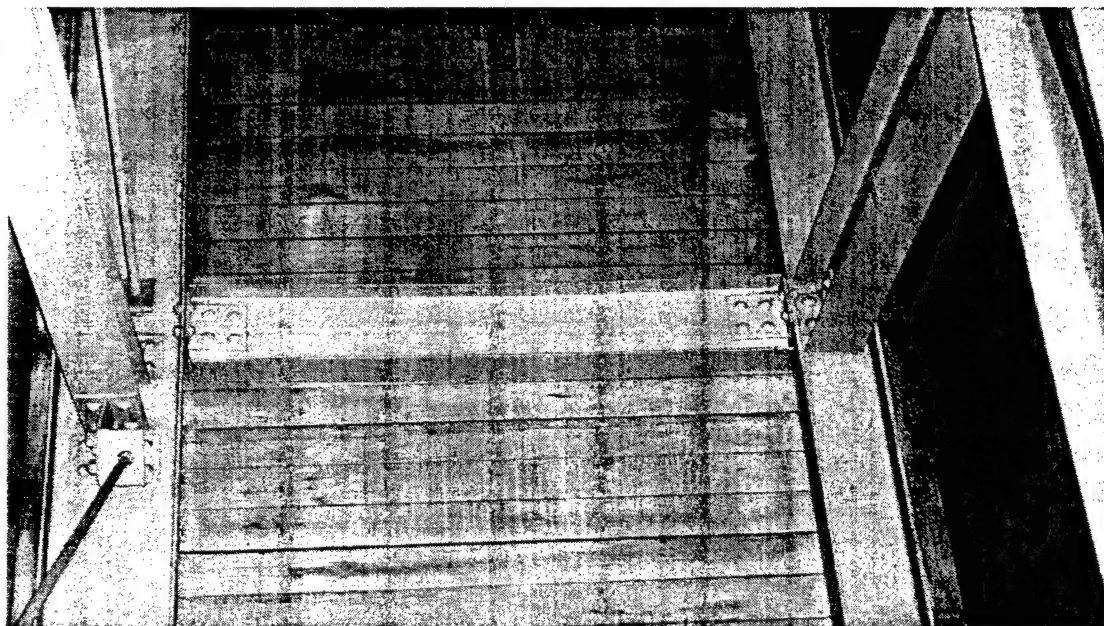
Figure A-2. Buckled horizontal brace (10-I-21), second floor between Columns P5.5 and N5.5.

2. Tighten or replace loose tie rods (7/8 in. diameter) attached to columns P0.5, P1.5, P4.5, P5.5.
3. The buckling horizontal brace (10-I-21) on the second floor, between columns P5.5, N5.5, is not designed for compression, but has been acting as a compression member. This brace is considered to be a secondary member. It would be possible to increase stiffness and strength through retrofit, but this would make connections more vulnerable to failure. Therefore, no retrofit is advised.

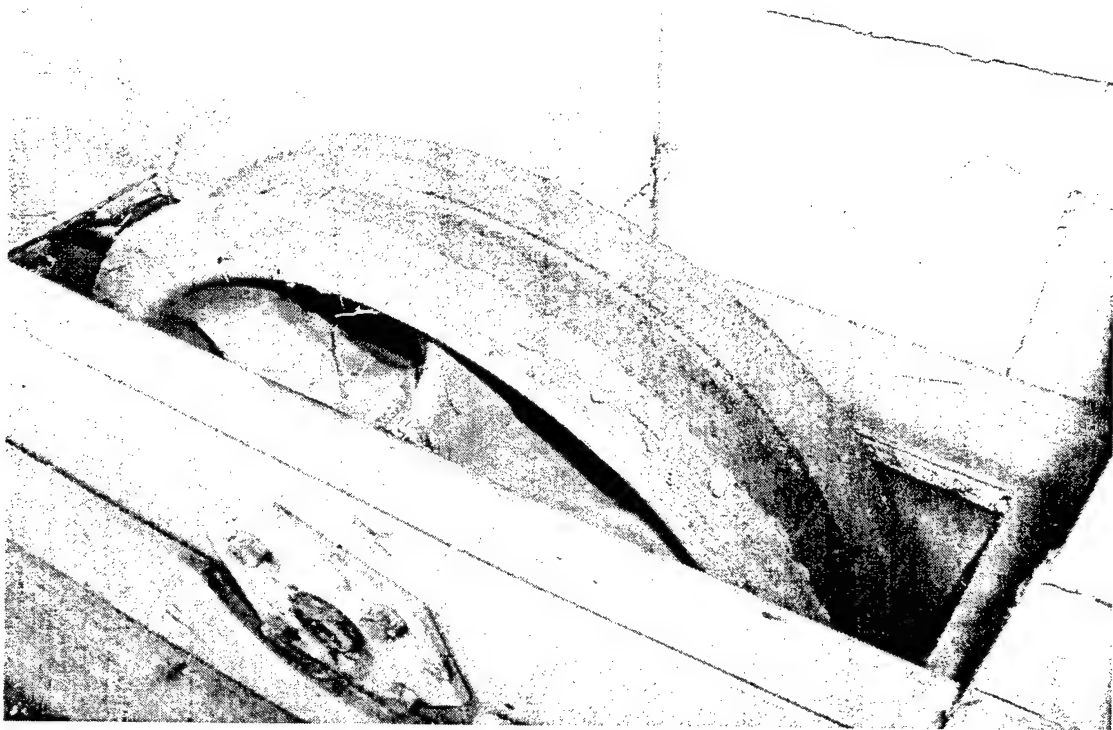
Figure A-3. A typical deteriorated hangar door wheel.

4. Deteriorated hangar door wheels should be replaced to ensure the strength of the door system under wind loading.
5. Dented vertical members near handles on hangar doors can result in loss of structural integrity of doors. Do not open doors with chains; use original design method for opening doors.

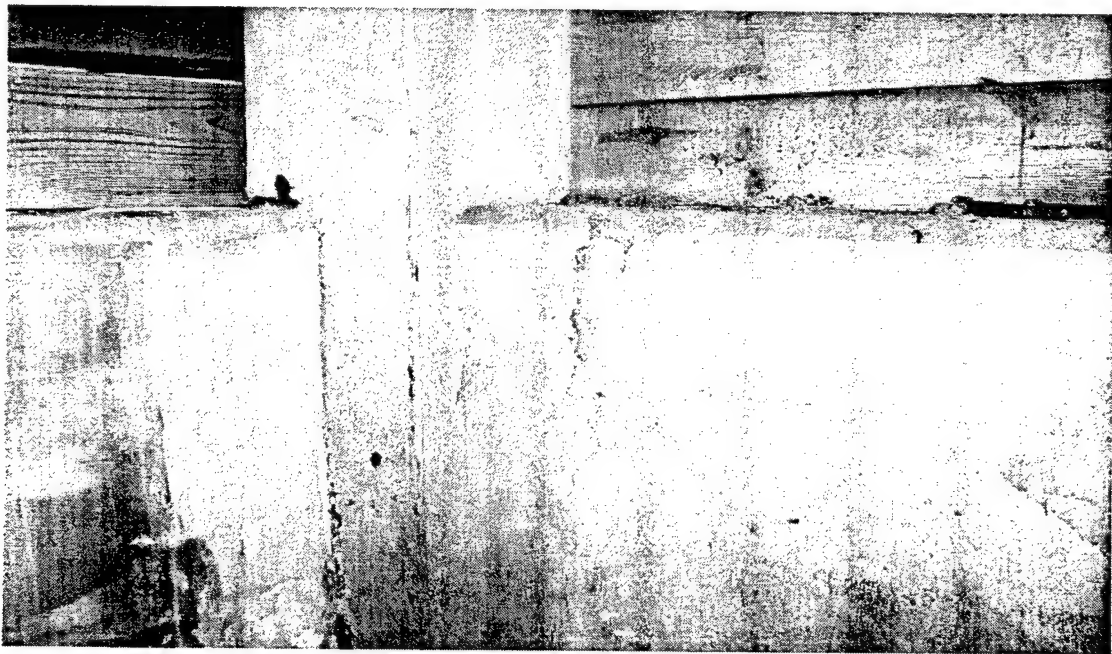
Figure A-4. Spalling concrete at the base of Column N5.5.

6. Remove spalling concrete from column N5.5 (8-H-31), sandblast rust off of the column structural steel, repair steel as shown in Figure D-4 of TR-99/27, and re-cast the concrete.

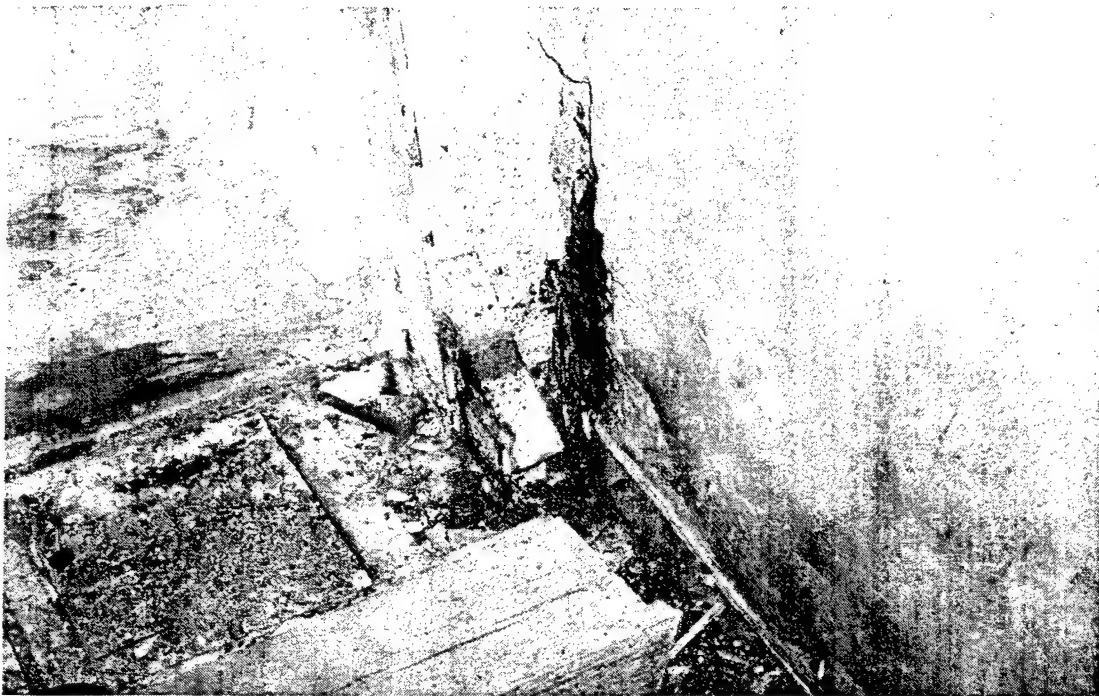
Figure A-5. Major corrosion sample retrieved from base of Column AO.5 (8-H-31).

7. Remove spalling concrete from column A0.5 (8-H-31), sandblast rust off of the column structural steel, repair steel as shown in Figure D-5 of TR-99/27, and re-cast the concrete.

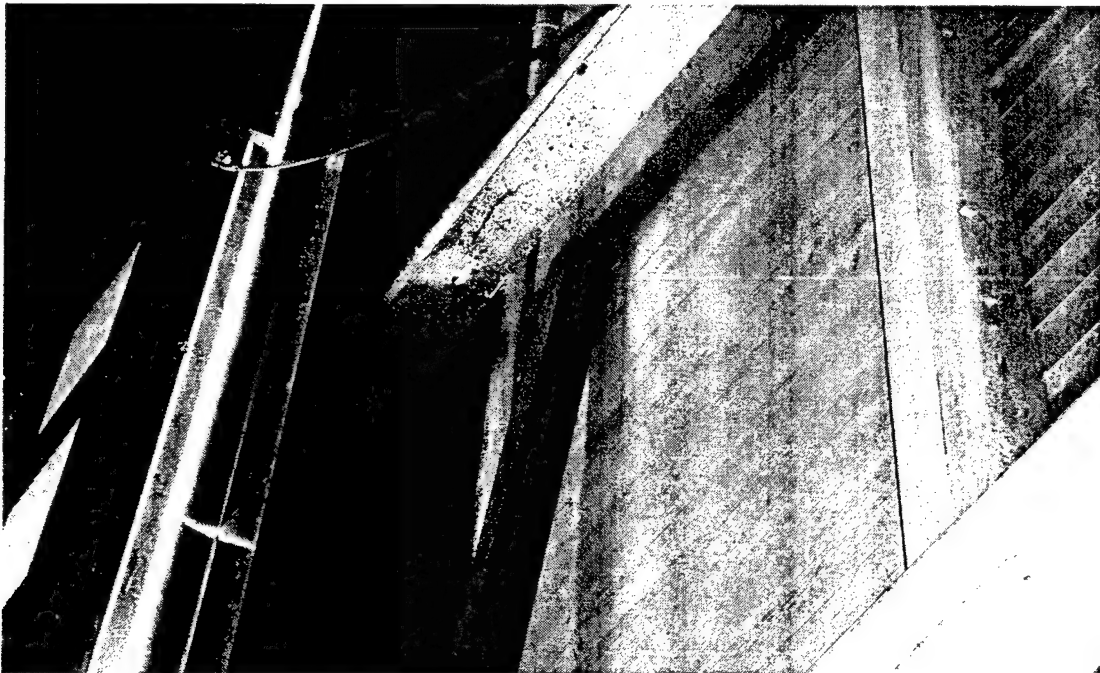
9. Unsupported wood column (4x4 post) near column AA2 is a safety hazard. See Figure A-6.
10. A makeshift wood column (4x4 post) near column AA2 provides inadequate support of second floor beam between columns AA2 and AA1.5. See Figure A-7.
11. A beam is under torsional stress at the second floor between columns AA4 and AA4.5 (6-H-15.5).
12. Major corrosion of the web and flange at the base of column A5 (18-I-47) has resulted in an estimated 30 percent strength reduction. See Figure A-8.
13. Minor corrosion of the web and flange at the base of column A5.5 (8-H-31) has resulted in an estimated 10 percent strength reduction. See Figure A-9.

Figure A-6. Loose timber near Column AA2.

8. If the base and anchorage of column AA0.5 (12-I-25) are sufficient, repair as shown in Figure D-4 of TR-99/27; if not, repair as shown in Figure D-5 of TR-99/27.
9. Remove unsupported wood column (4x4 post) at column AA2.
10. Remove makeshift wood column (4x4 post) near column AA2 or securely brace the column to the beams.
11. Retrofitting beam 6-H-15.5 on the second floor, to stiffen and strengthen it between columns AA4 and AA4.5, would make connections vulnerable to failure. Therefore, no retrofit is advised.
12. Repair column A5 (18-I-47) as shown in Figure D-5 of TR-99/27.
13. Repair column A5.5 (8-H-31) as shown in Figure D-5 of TR-99/27.

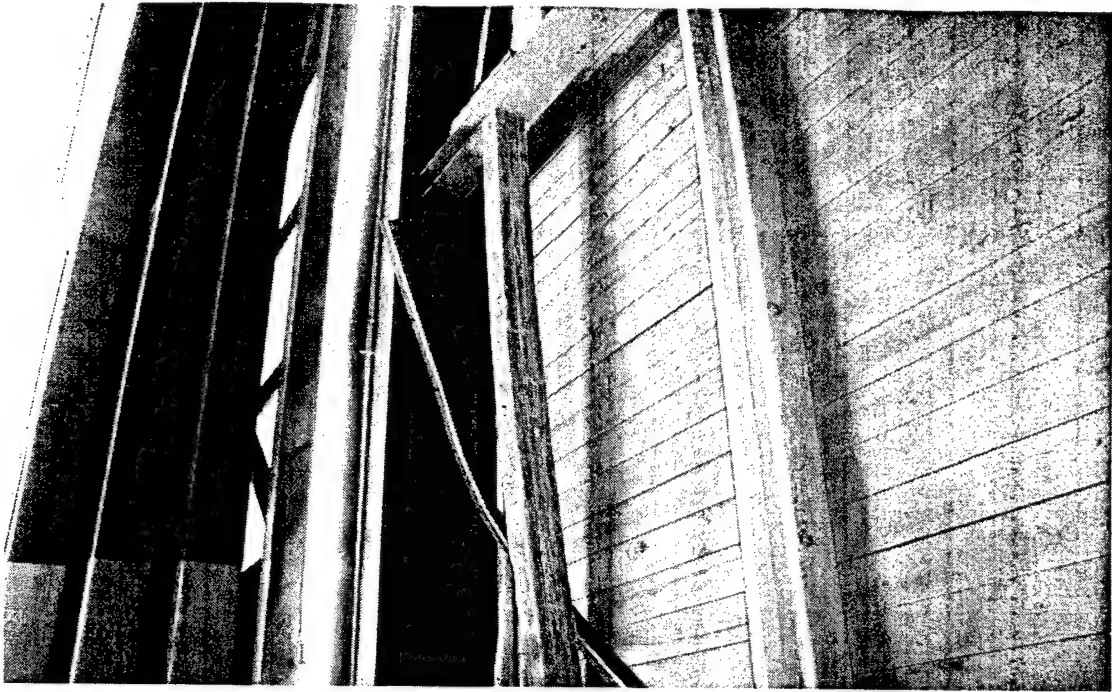
Figure A-7. Makeshift support near Column AA2.

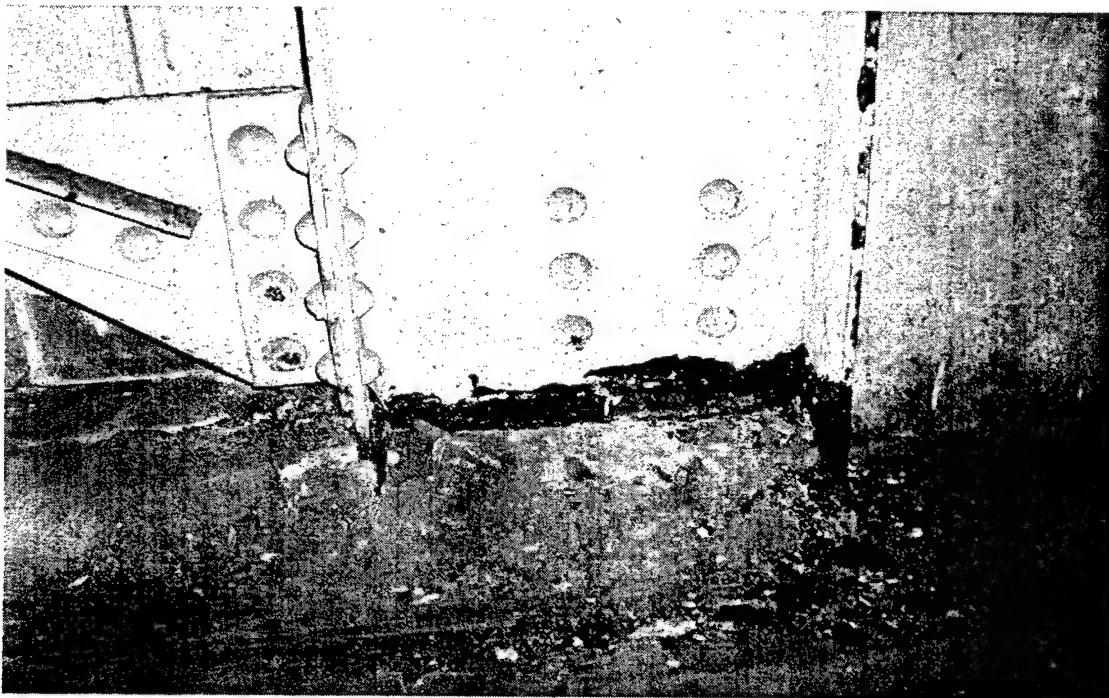
Figure A-8. Major corrosion at base of Column A5 (18-I-47).

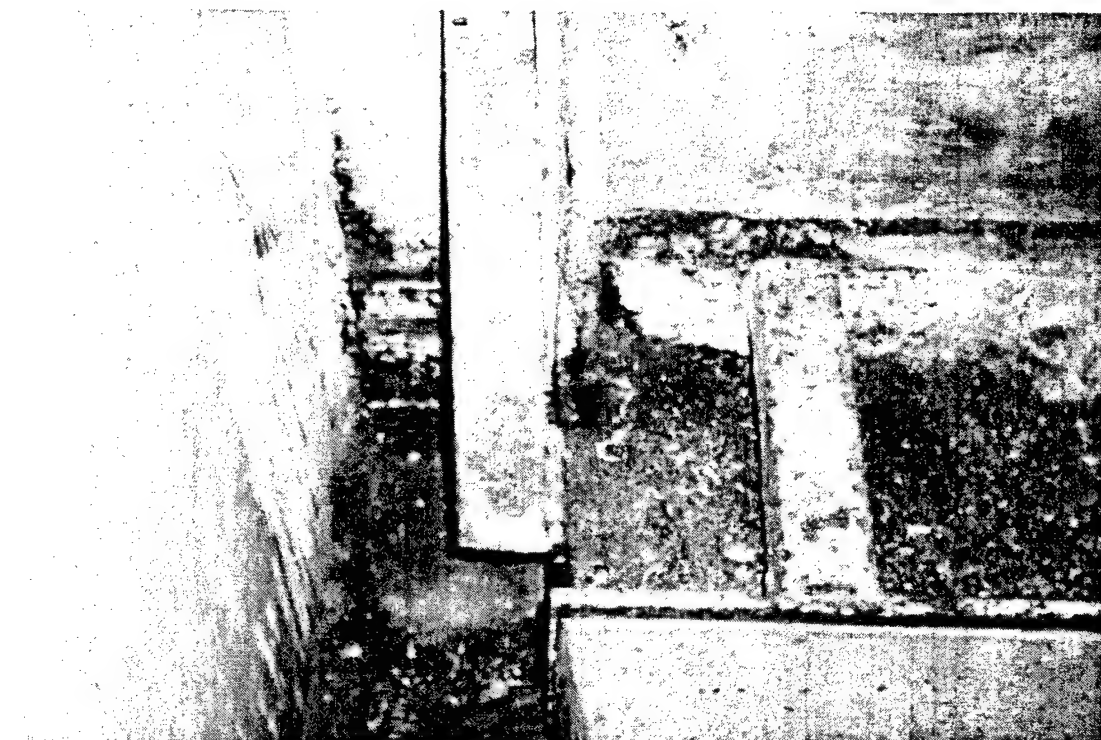
Figure A-9. Minor corrosion at the base of Column A5.5 (8-H-31).

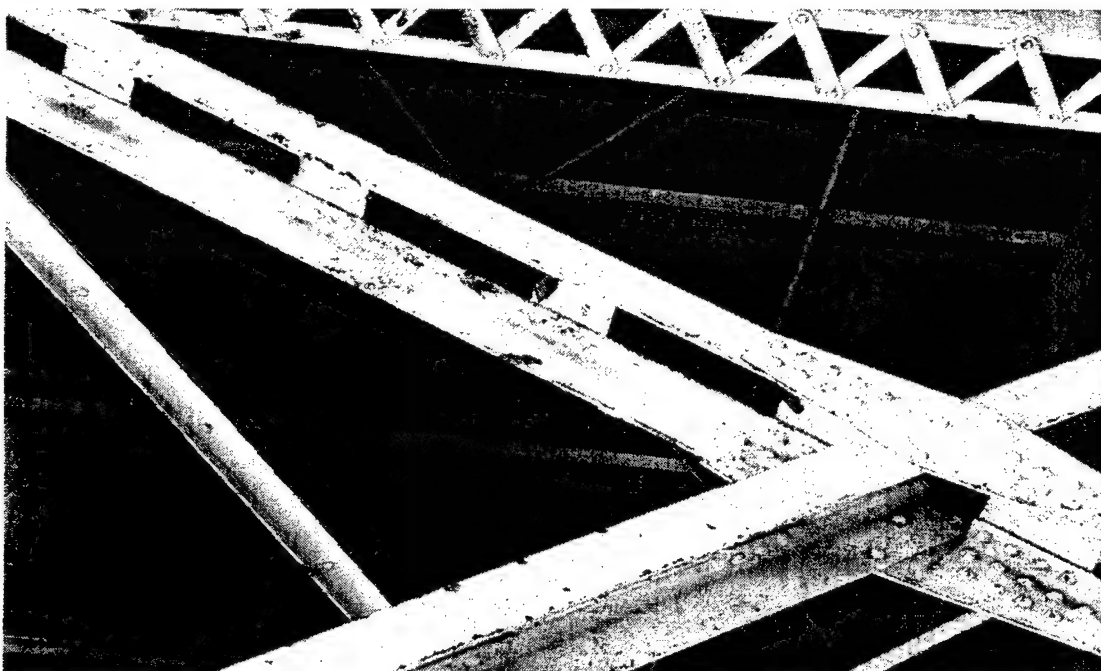
14. Entire hangar is losing paint. See Figure A-10.
15. Minor buckling of diagonal braces (single angle,  $3\frac{1}{2} \times 2\frac{1}{2} \times \frac{1}{4}$ ) has occurred at the following locations:

Figure A-10. Typical example of elements needing fresh paint.

14. Any unpainted steel needs to be painted; use as listed in Figure D-1 of TR-99/27.
15. No retrofits are necessary for buckling bracing members listed in notes 15 and 16 of Chapter 2; these angles are intended for tension only.
16. No retrofit is necessary for column K2 (18-I-85), but further welding damage and gouging of the sort identified here should be avoided.

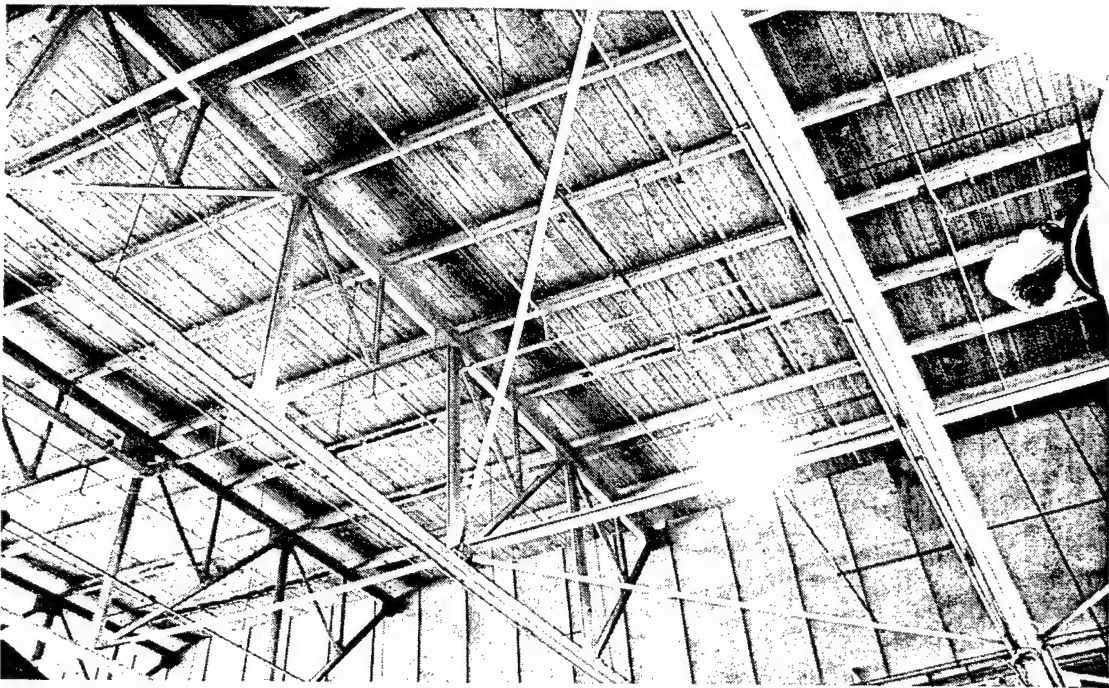
- between columns G2.4 and H2.5; see Figure A-11
  - between columns L2.5 and M3; see Figure A-12.
16. Buckling of bottom braces (single angle,  $3\frac{1}{2} \times 2\frac{1}{2} \times \frac{1}{4}$ ) has occurred at the following locations:

Figure A-11. Buckled diagonal between Columns G2.4 and H2.5.

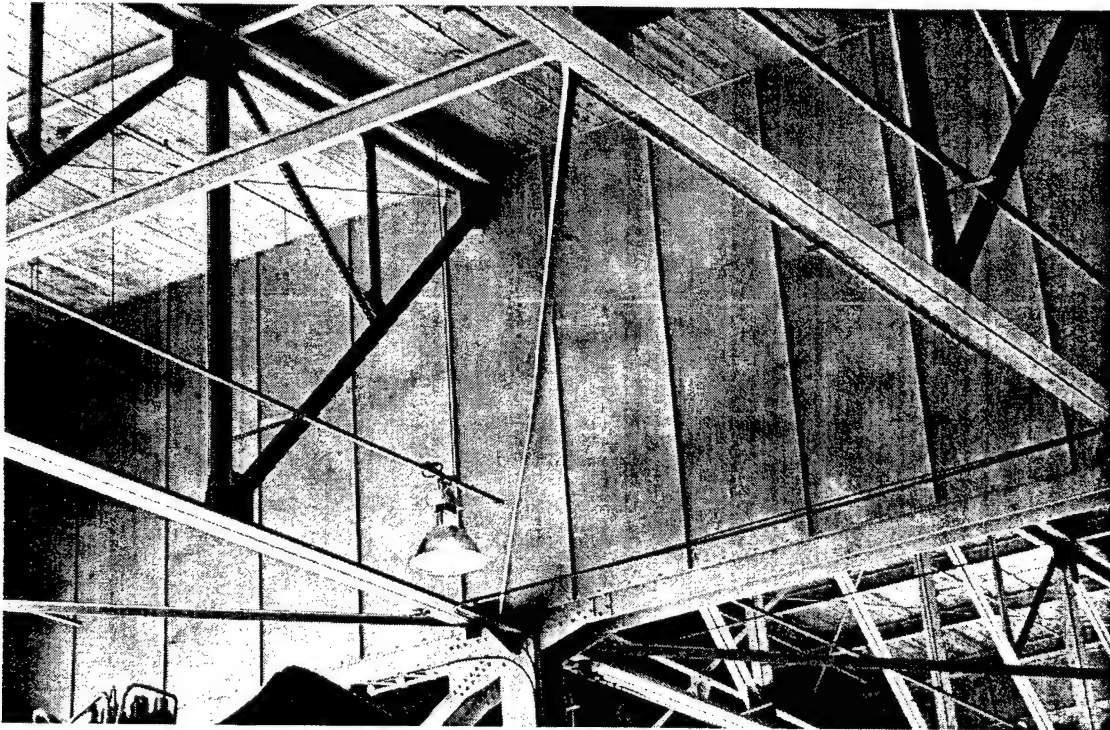
Figure A-12. Buckled diagonal between Columns L2.5 and M3.

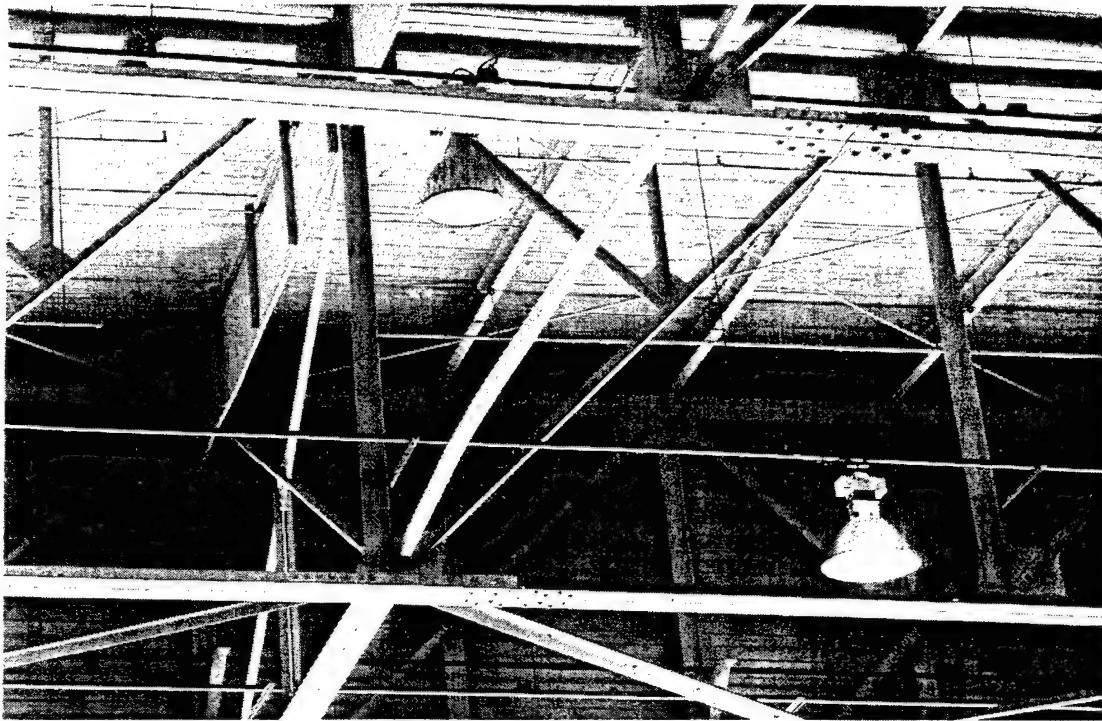
- between columns L2.4 and M2.4; see Figure A-13
  - between columns H2.5 and J2.5; see Figure A-14
  - between columns C2.5 and E2.5; see Figure A-15
  - between columns E3.1 and F3.1; see Figure A-16

Figure A-13. Buckled bottom chord between Columns L2.4 and M2.4.

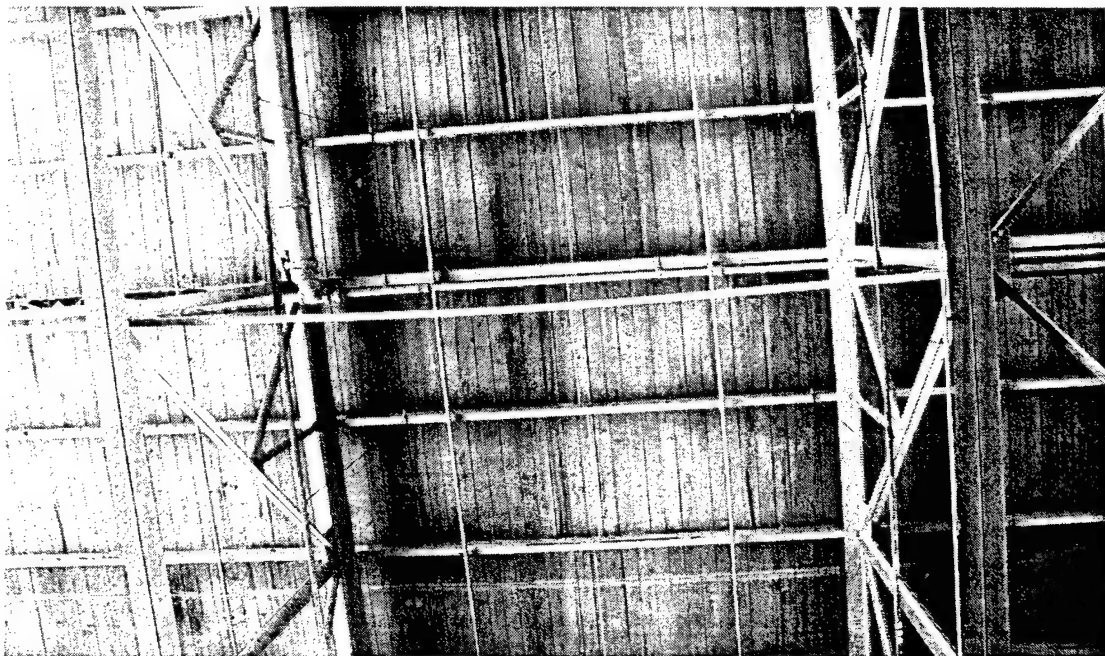
Figure A-14. Buckled bottom chord between Columns H2.5 and J2.5.

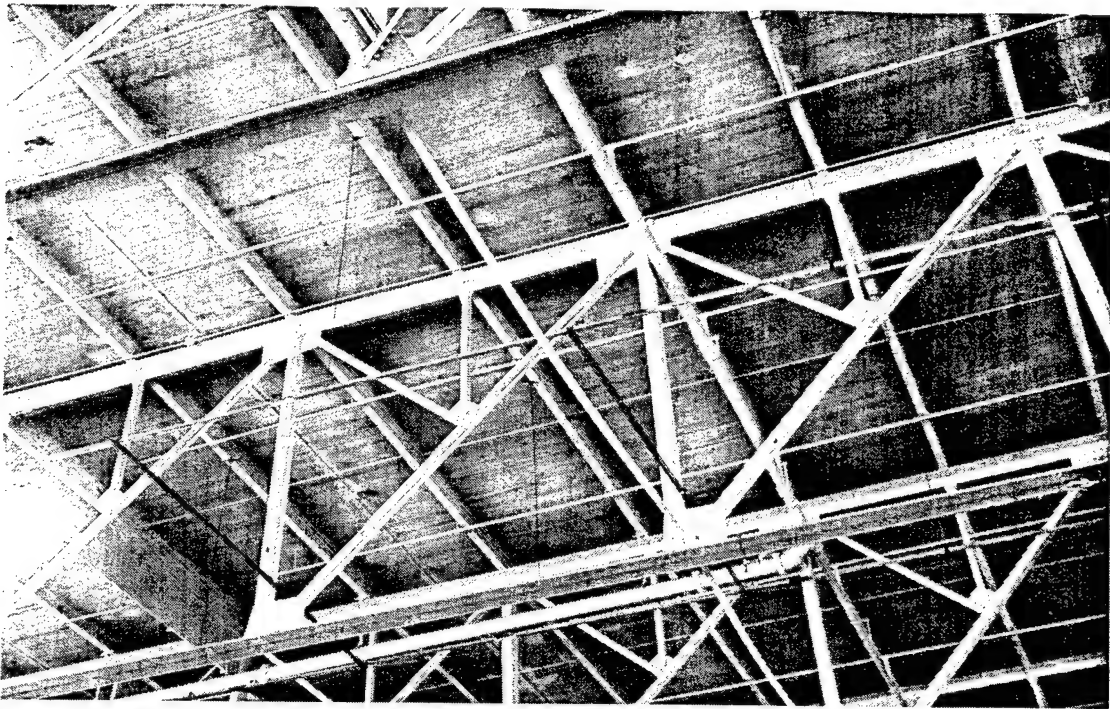
Figure A-15. Buckled bottom chord between Columns C2.5 and E2.5.

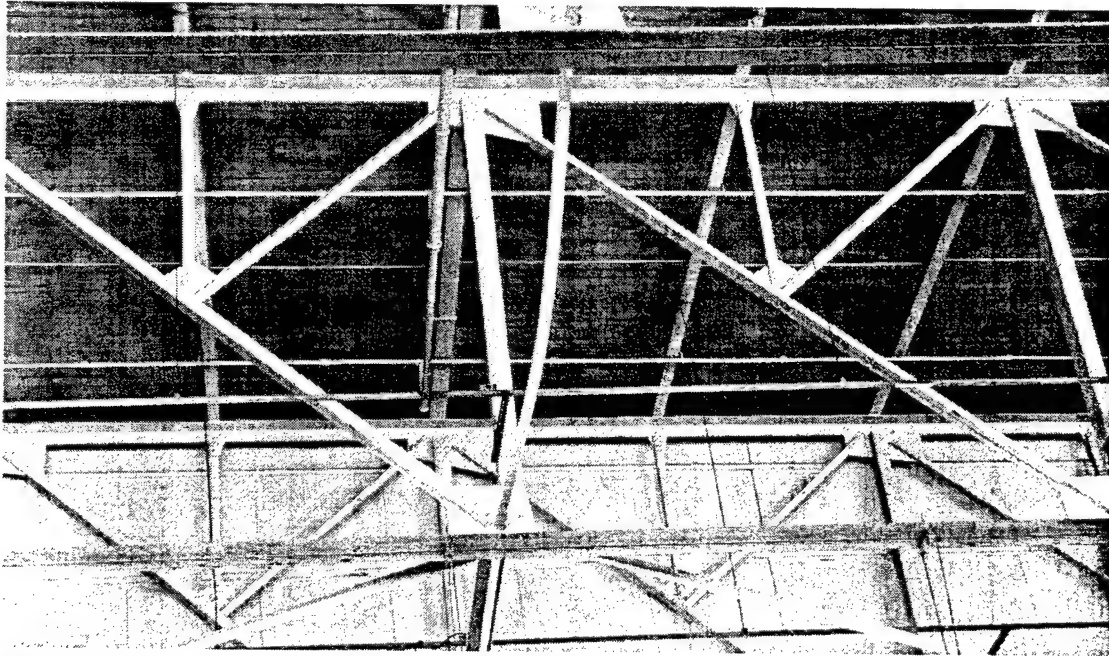
Figure A-16. Buckled bottom chord between Columns E3.1 and F3.1.

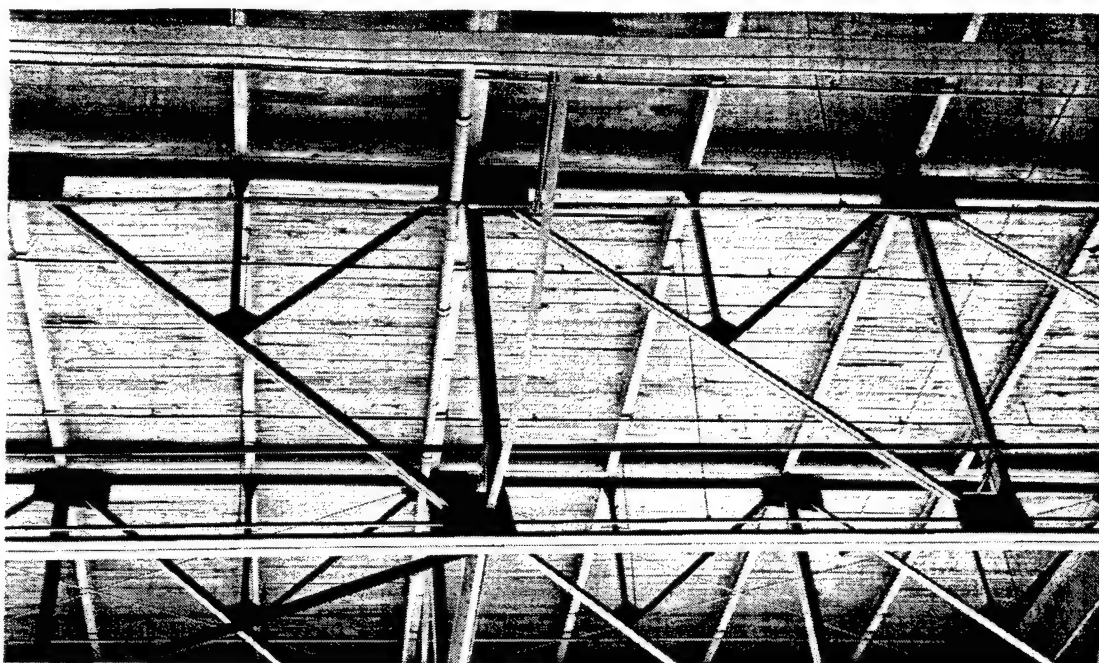
- between columns K3.1 and L3.1; see Figure A-17
  - between columns H3.2 and J3.2; see Figure A-18
  - between columns L3.4 and M3.4; see Figure A-19
  - between columns E3.4 and F3.4; see Figure A-20.

Figure A-17. Buckled bottom chord between Columns K3.1 and L3.1.

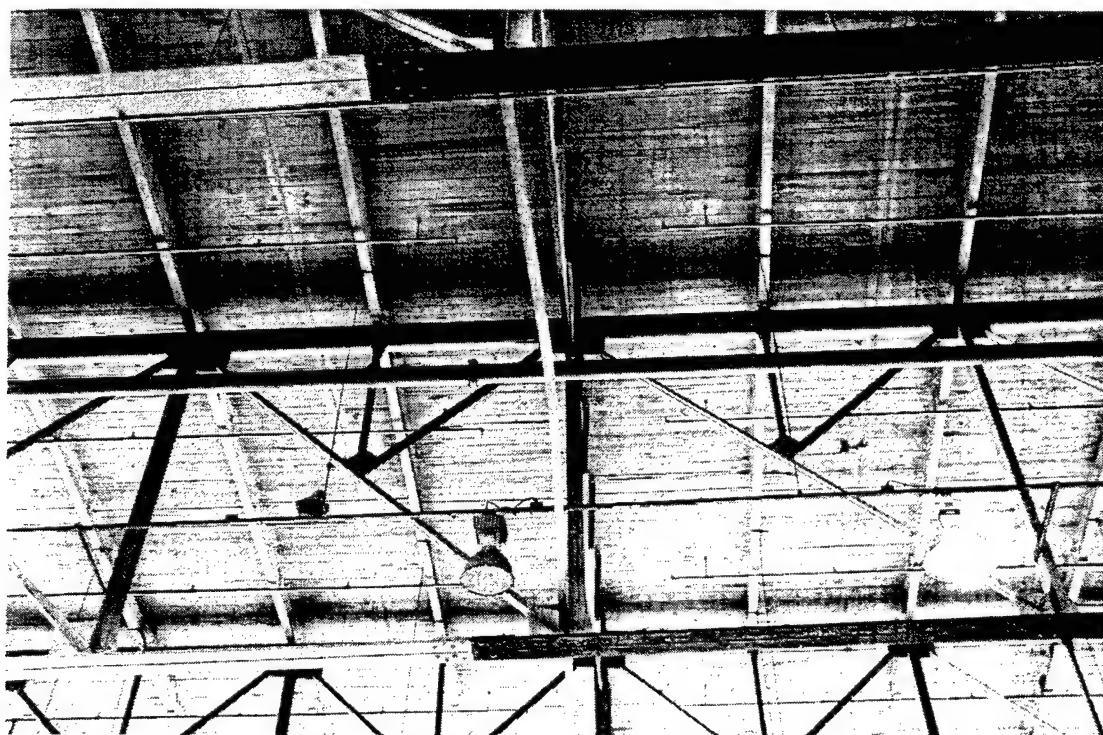
Figure A-18. Buckled bottom chord between Columns H3.2 and J3.2.

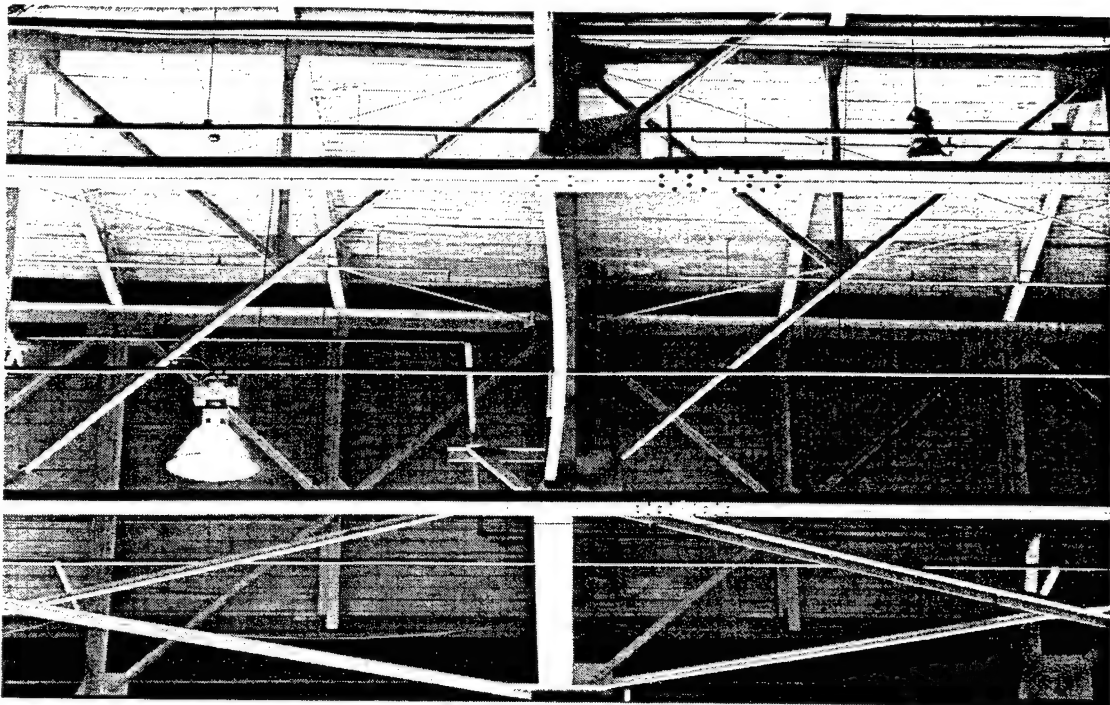
Figure A-19. Buckled bottom chord between Columns L3.4 and M3.4.

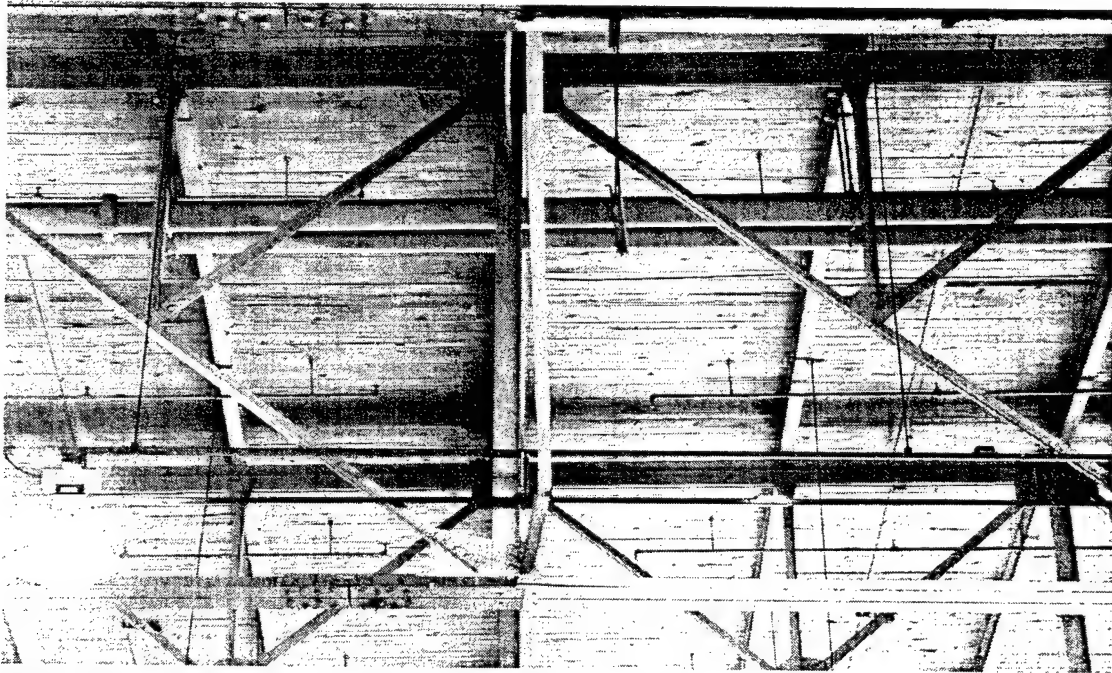
Figure A-20. Buckled bottom chord between Columns E3.4 and F3.4.

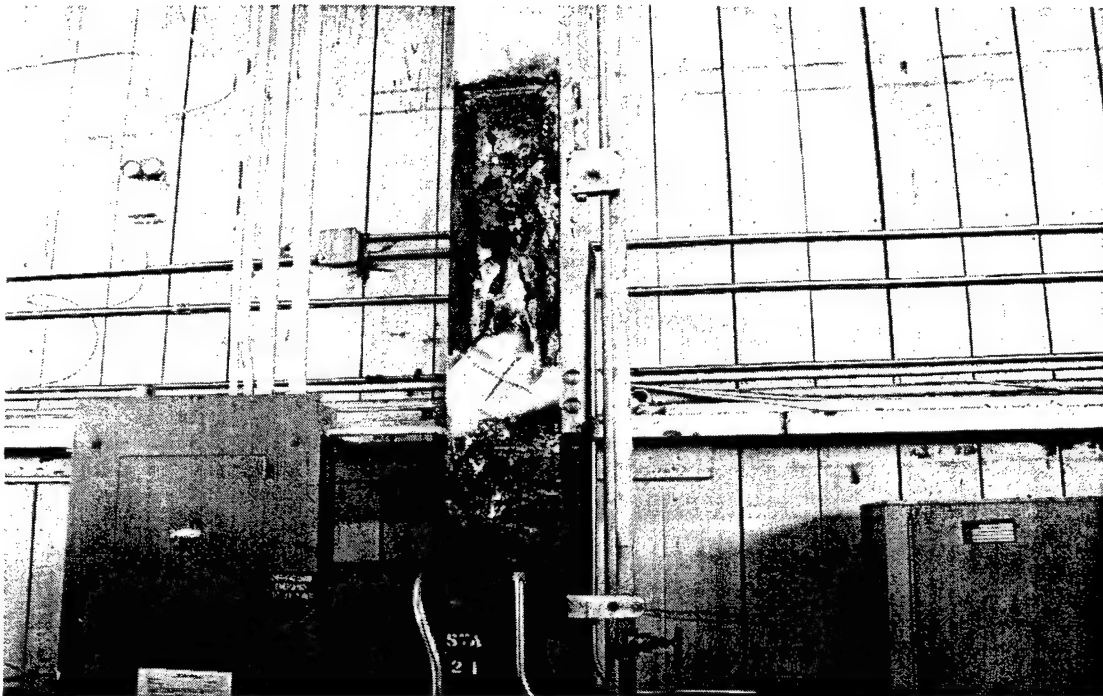
17. A column located at K2 (18-I-85) has been damaged from welding and gouging, resulting in an estimated 5 percent strength reduction. See Figure A-21.

Figure A-21. Damage to Column K2 (18-I-85).
